Point of View Home Inspection LLC.

Property Inspection Information

01/24/2017

West Seneca, NY 14224

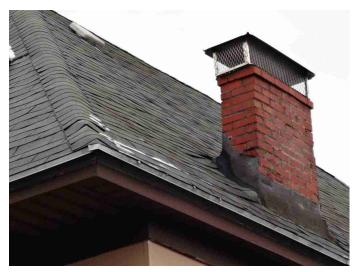
Roof Structure - (viewed from Exterior) - SLIGHT IRREGULARITIES NOTED

This may be caused by excessive weight, undersized structural members or decking, or minor settling of the structure due to age. The inspector feels that this amount of movement will not affect the serviceable life of the roof covering; however, these areas should be closely monitored and repaired as necessary. Recommend evaluation and reinforcement if necessary when the roof covering is replaced.

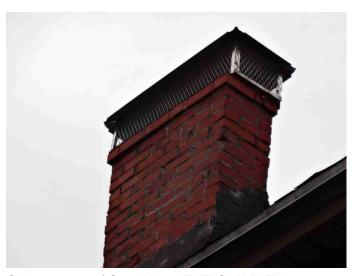
Chimney type / Condition - THE CHIMNEY SHOULD BE TUCK POINTED / MORTARED Tuck pointing is the process where mortar that has come out or separated from between the masonry is replaced. This should be done in order to ensure the integrity of the chimney and prevent water intrusion.

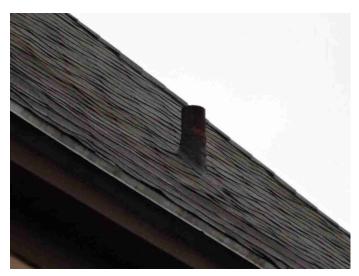
Flashing / Counter flashing - SATISFACTORY / SERVICEABLE

This indicates that areas of flashing able to be viewed by the inspector appear to be in satisfactory condition. Some areas of flashing can not be viewed. Examples of these areas are concealed flashing under roof covering, behind chimneys, behind walls, etc. TAR FLASHING JOINTS NEED TO BE MONITORED AS IT IS A TEMPORARY REPAIR

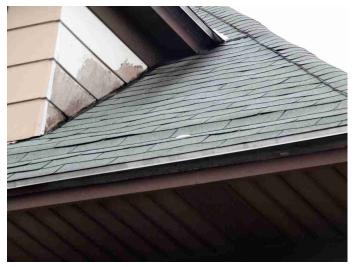
Siding - MINOR DECAY / DAMAGE / PEELING / CRACKING / CORROSION - These areas should be scraped, primed, and painted or stained. Any decayed / damaged sections should be replaced.

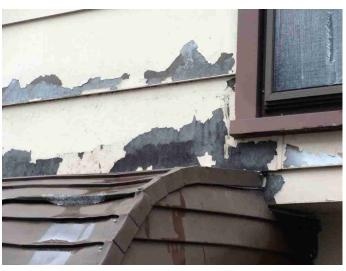
Siding - MINOR DECAY / DAMAGE / PEELING / CRACKING / CORROSION - These areas should be scraped, primed, and painted or stained. Any decayed / damaged sections should be replaced.

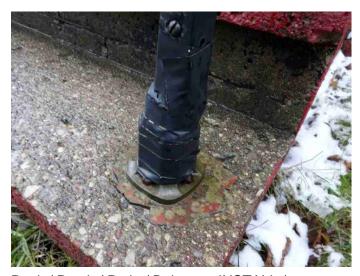
Deck / Porch / Patio / Balcony - INSTALL /
REINFORCE / REPLACE HANDRAILINGS
The railings should be replaced or rebuilt for safety.
ELECTRICAL TAPE NOTED AT THE FRONT
PORCH RAILING

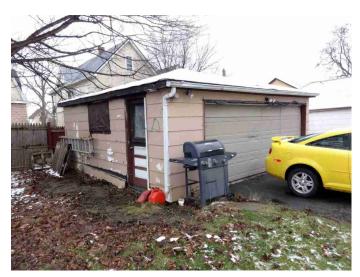
Garage Type / Materials / General condition - MINOR DECAY / DAMAGE

These areas should be closely monitored and repaired or replaced to ensure further damage or settling does not occur to the garage and its structure. NOTED AT THE FASCIA AND AT THE SILL PLATE

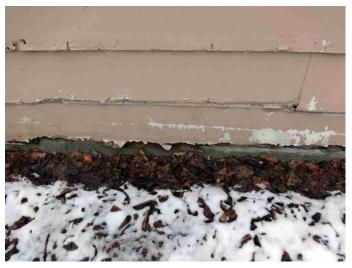
Garage Type / Materials / General condition - MINOR DECAY / DAMAGE

These areas should be closely monitored and repaired or replaced to ensure further damage or settling does not occur to the garage and its structure. NOTED AT THE FASCIA AND AT THE SILL PLATE

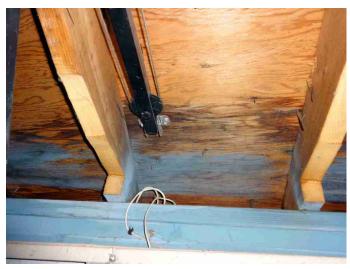
Roof Covering - OTHER LIFTED SHINGLE NOTED WHICH APPEARS TO BE BECAUSE OF THE GARAGE DOOR OPENER RAIL MOUNTING

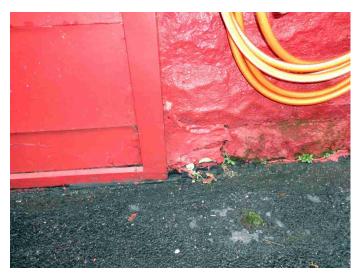
Type / Location / How accessed / Viewed /
Condition - Spalling Noted - EXTERNAL
Spalling is the deterioration of the masonry surface.
This takes place due to moisture behind the wall.
The source of moisture should be located and eliminated.

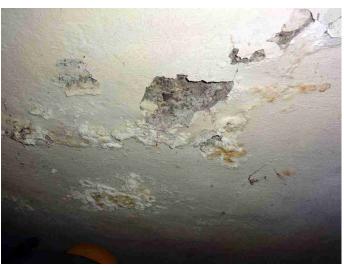
Type / Location / How accessed / Viewed / Condition - Spalling Noted - INTERNAL Spalling is the deterioration of the masonry surface. This takes place due to moisture behind the wall. The source of moisture should be located and eliminated.

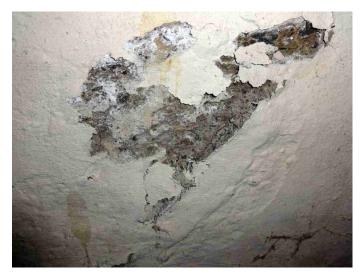
Type / Location / How accessed / Viewed / Condition - Spalling Noted - INTERNAL Spalling is the deterioration of the masonry surface. This takes place due to moisture behind the wall. The source of moisture should be located and eliminated.

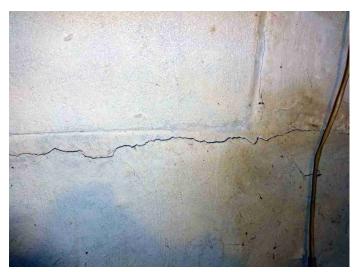
Type / Location / How accessed / Viewed /
Condition - Horizontal Cracking - INTERNAL
When a wall begins to bow, horizontal cracks may
appear. Even small horizontal cracks may indicate a
serious structural problem. If not addressed, and if
the wall continues to bow, the integrity of the
foundation may be compromised. Recommend
immediate evaluation by a structural engineer.

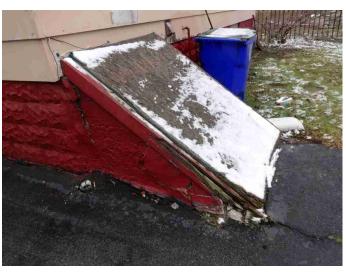
Outside Basement Entrance - CONSIDERABLE DAMAGE NOTED TO OUTSIDE ENTRANCE The areas of the entryway / entrance will have to be rebuilt. Recommend evaluation by a structural engineer. ALSO THE DOOR INTO THE BASEMENT IS SEALED OFF ON THE INSIDE

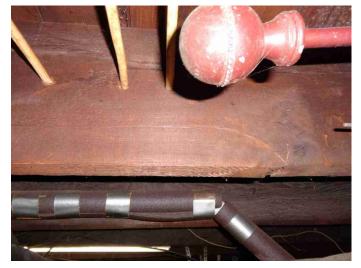
Joists / Sills - OTHER CRACKED JOIST NOTED AND SHOULD BE REPAIRED OR REPLACED

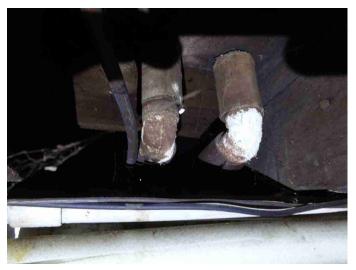
Supply / Return Ducts / Pipes - UNKNOWN
MATERIAL / SUBSTANCE INSULATING DUCTS /
PIPES / UNIT RECOMMEND TESTING FOR
ASBESTOS

The inspector has indicated that there is an unknown substance / material insulating the ducts or lines. The only way to positively identify this material is to have an approved lab test it for hazardous material including Asbestos. Asbestos is a carcinogen. If Asbestos or another hazardous material is detected, recommend having it properly removed by a qualified environmental company.

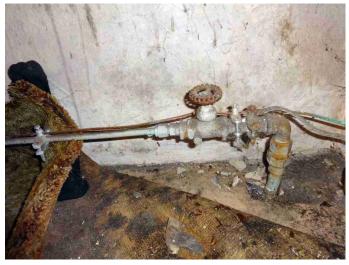
Water Source - 3/8 INCH
THE SUPPLY PIPES APPEAR TO BE SEVERELY
UNDERSIZED AND NEED TO BE EVALUATED BY
A LICENSED PLUMBER

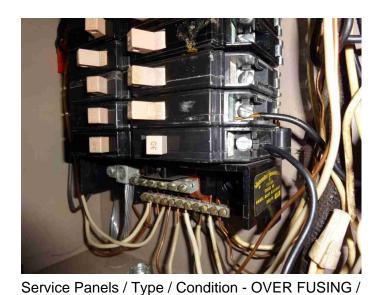
(Amperage of over current protection device exceeds wire conductor capacity)

The fuse or circuit breaker is not sized correctly for the branch circuit conductors it is protecting. This may cause overheating and possibly a fire.

Recommend immediate evaluation and repair by a licensed electrician. If fuses are present, a licensed electrician could install "S" type fuses. This will ensure the correct size fuse is used. THERE ARE TWO OVER FUSING CONDITIONS NOTED. ONE

IN EACH ELECTRIC PANEL

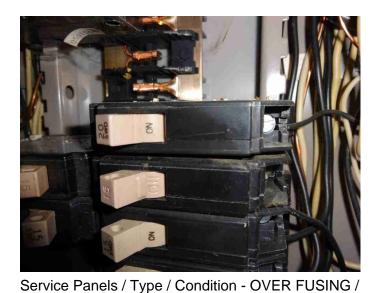
(Amperage of over current protection device exceeds wire conductor capacity)

The fuse or circuit breaker is not sized correctly for the branch circuit conductors it is protecting. This may cause overheating and possibly a fire.

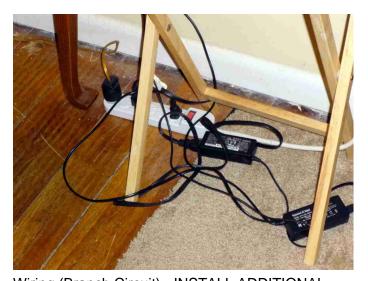
Wiring (Branch Circuit) - INSTALL ADDITIONAL RECEPTACLES / SWITCHES (if desired)
When this dwelling was built, the amount of switches / receptacles were adequate. It may be necessary to install additional switches / receptacles for convenience. NUMEROUS EXTENSION CORDS NOTED IN THE BEDROOMS INDICATING THE LACK OF ELECTRICAL RECEPTACLES.

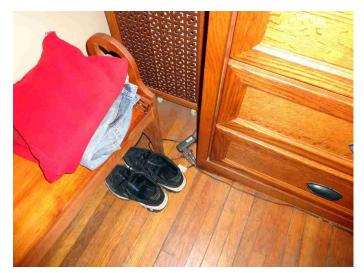
Wiring (Branch Circuit) - INSTALL ADDITIONAL RECEPTACLES / SWITCHES (if desired)
When this dwelling was built, the amount of switches / receptacles were adequate. It may be necessary to install additional switches / receptacles for convenience. NUMEROUS EXTENSION CORDS NOTED IN THE BEDROOMS INDICATING THE LACK OF ELECTRICAL RECEPTACLES.

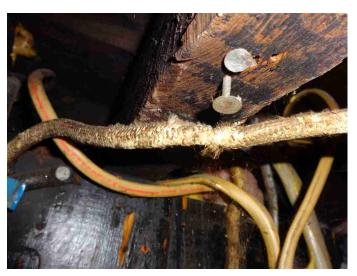
Conductor Insulation - Branch Circuits - SOME DRY ROT NOTED TO INSULATION ON BRANCH CIRCUIT(S)

The insulation in these areas should be closely monitored for further dry rot, fraying, or damage and replaced as necessary by a licensed electrician.
