Point of View Home Inspection LLC.

Property Inspection Information

01/24/2017

West Seneca, NY 14224

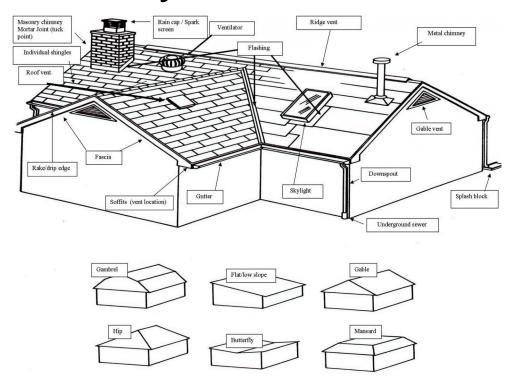
Section 1: Roof System

SLIGHT IRREGULARITIES NOTED

This may be caused by excessive weight, undersized structural members or decking, or minor settling of the structure due to age. The inspector feels that this amount of movement will not affect the serviceable life of the roof covering; however, these areas should be closely monitored and repaired as necessary. Recommend evaluation and reinforcement if necessary when the roof covering is replaced.

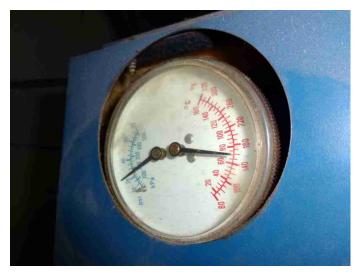
Response - Thermostat / Control / System - A 140,000

Response - Thermostat / Control / System - THE UNIT RESPONDED TO THE THERMOSTAT CONTROLS

The unit responded satisfactorily to the thermostat or the controls at the time of inspection.
